**Operation and Maintenance Report
January 2016 to December 2016**

McCormick and Baxter Superfund Site

Portland, Oregon

March 23, 2017

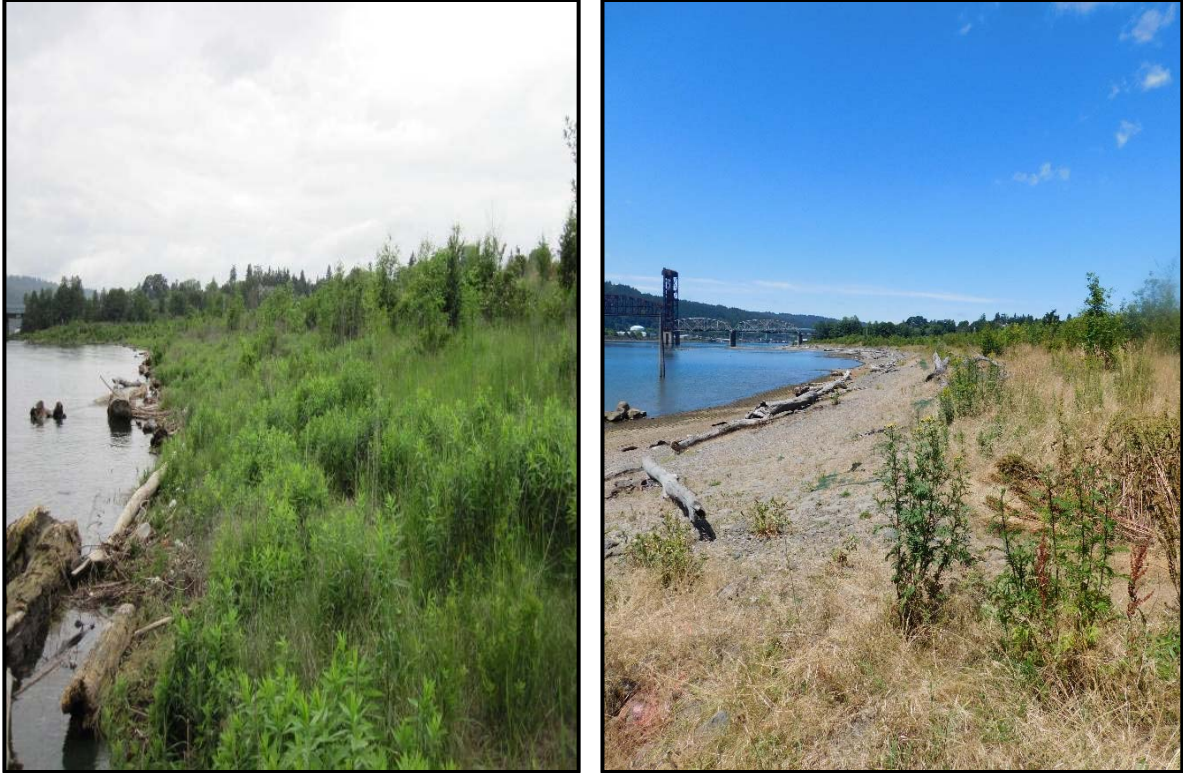
Photograph 9 – Lower riparian component with large wood debris along the edge. Taken looking northwest from Photograph Location 9 comparing baseline and current conditions. (Left - June 2011, Right – June 2016)

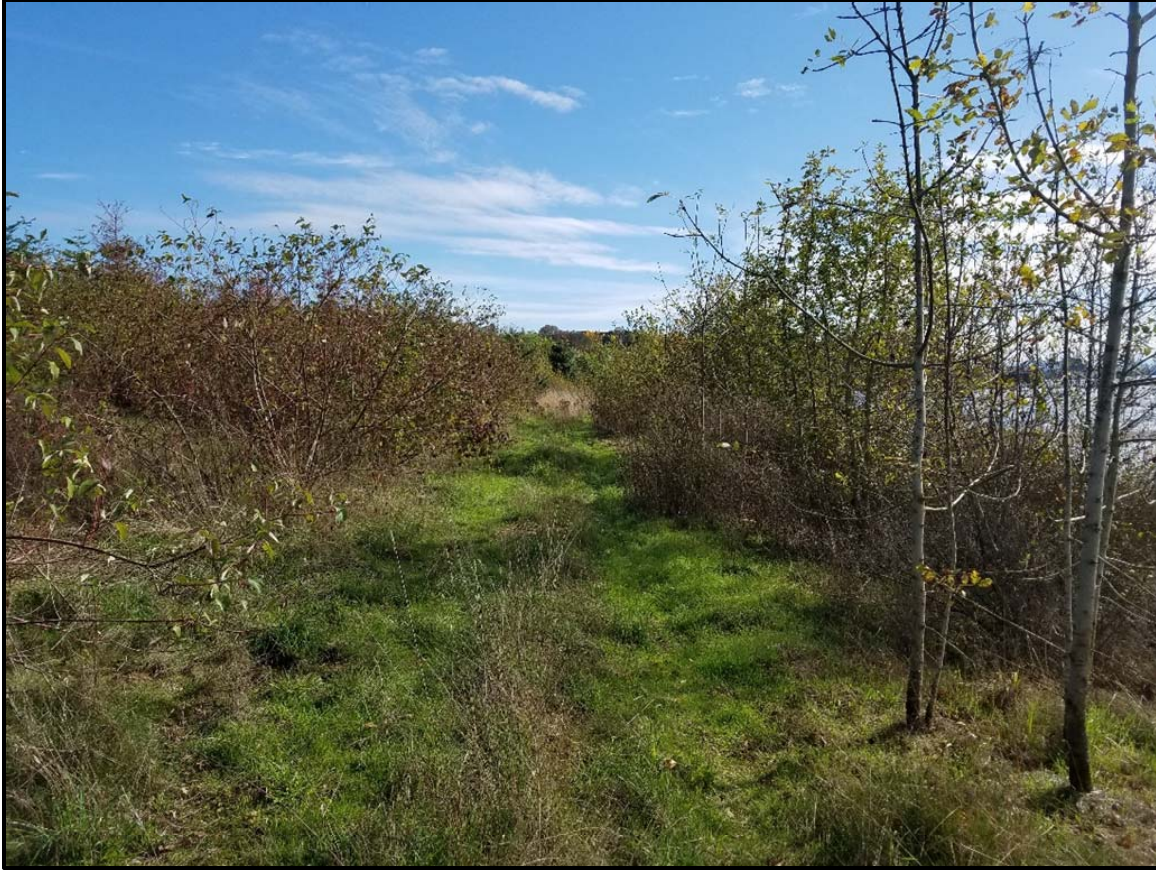
Photograph 10 – North end of the lower riparian area, looking east. Oregon ash, red osier-dogwood, and nootka rose are faring relatively well within this area. (October 2016)
